Whatcom County
On-site Sewage System
(OSS)
Report Of System Status

Site		Evaluation	
Site Address	8085 AUDRA LN	Evaluation Date	a8289742 7/22/2025
Parcel (first 12 digits)	400230138422	OM Specialist	Nate Macy
Property ID	177302	Customer Name	JERRY CRABTREE
OSS SiteID	18226	Customer Phone	360-000-0001
OSS Site Description		Performed For	Routine Compliance
Scanned OSS Doc	Yes	Sewage Source	Single Family
OSS Type	Gravity	Bedrooms Served	2
Proprietary Treatment Product	No	Certified to perform maintenance for this proprietary product	
Sand Filter	No

8085 AUDRA LN (400230138422) Site-18226 Eval-a8289742 on 07/22/2025

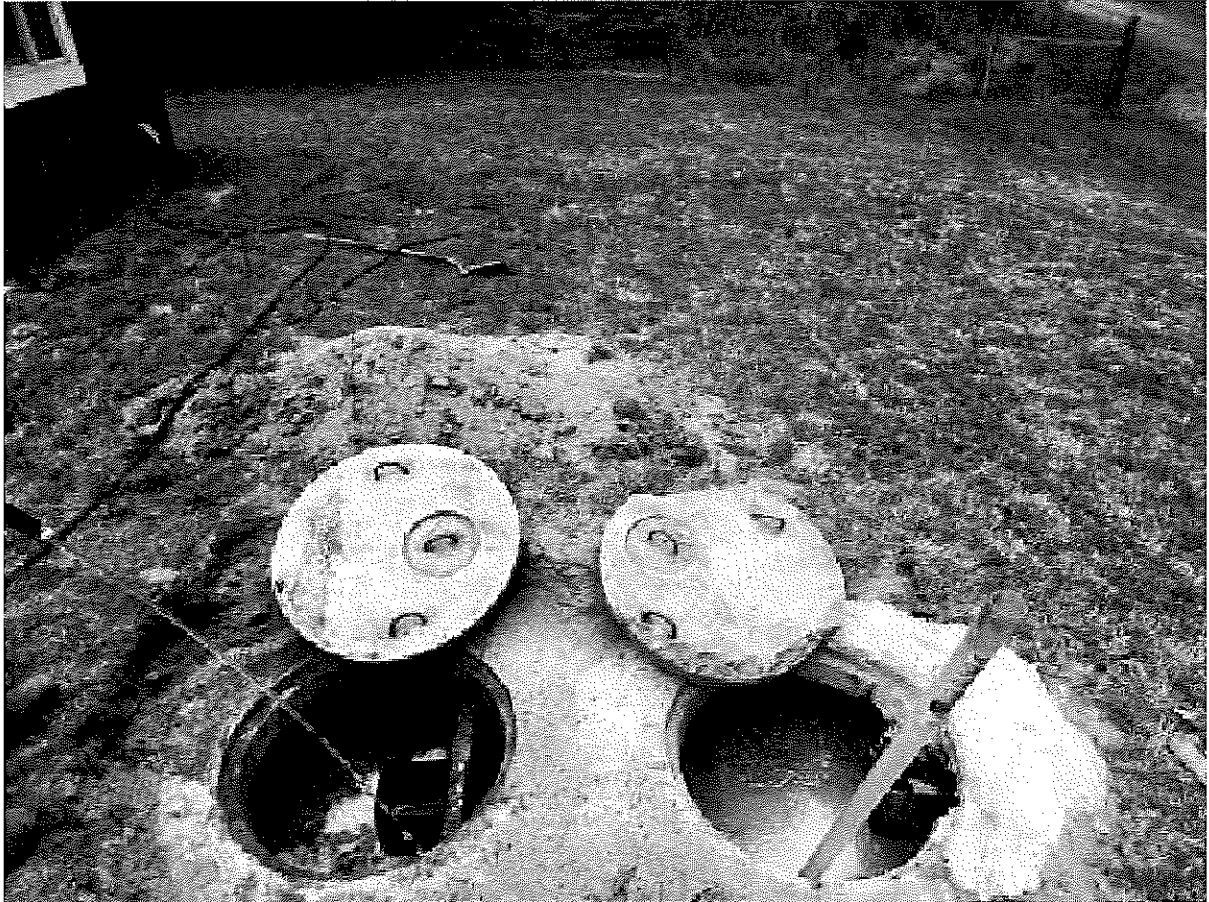
Photo - Misc: Septic Tank

Septic Tank Watertight	Yes
Septic Tank Scum Depth at Inlet (inches)	3.00
Septic Tank Sludge Depth at Inlet (inches)	3.00
Septic Tank Sludge Depth at Outlet (inches)	2.00
Septic Tank Scum Depth at Outlet (inches)	0.00
Septic Tank Pumping Required	No, pumping not required
Septic Tank Inlet baffle condition	Satisfactory
Septic Tank Outlet baffle condition	Satisfactory
Septic Tank Outlet filter	Not present
Outlet filter cleaned	
Septic Tank Condition of Risers	Not present
Septic Tank Condition of Lid:	Satisfactory
Septic Tank Lids Secured	Yes
Septic Tank Comments

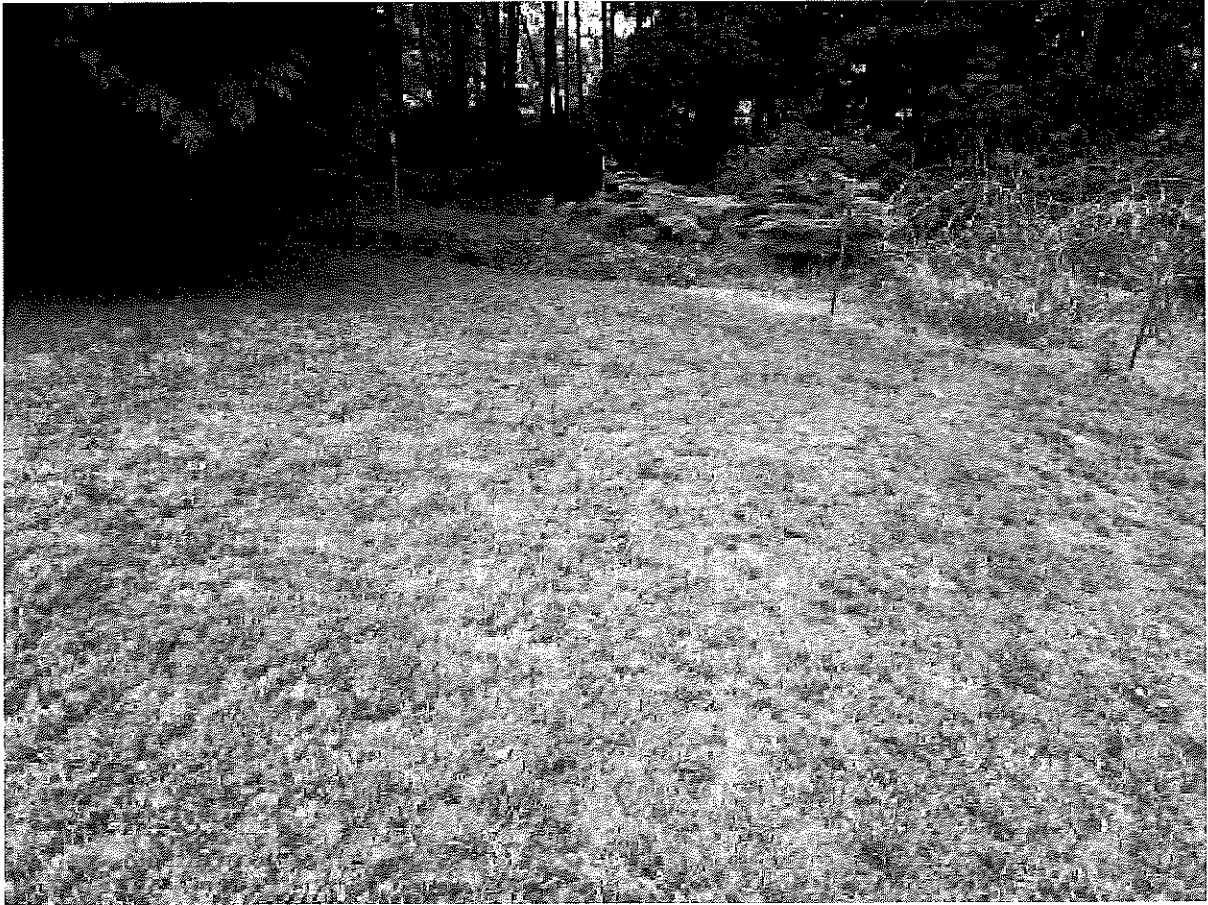
Photo - Misc2: Drainfield

Surface water/downspouts diverted away from drainfield	Yes
Improper encroachment (structures/impervious surfaces)	No
Structural Integrity and Vegetative Cover Properly Managed	Yes
Ponding, Seepage, or Saturation near/around Drainfield	No
Describe Ponding, Seepage, Saturation	
Monitoring Ports Condition	N/A
Is sewage ponding in ports	
Effluent at same level in all basins	
Distribution Box (surface access)	N/A
Distribution Box Condition	
Equal Distribution	
Diversion Valve present/functioning	
Laterals flushed - Drainfield	
Squirt Height At Distal End (inches)	
Orifice Size Used (inches)	
Equal Distribution - Drainfield	
Length Of Flow Test (minutes)	20.00
Approximate Gallons	120
