Geologic Report
for
Commercial Property

XXX 7th Ave NE
Parcel No. 142601-3-115-2005
Poulsbo, Washington

August 29, 2022
Project #22225

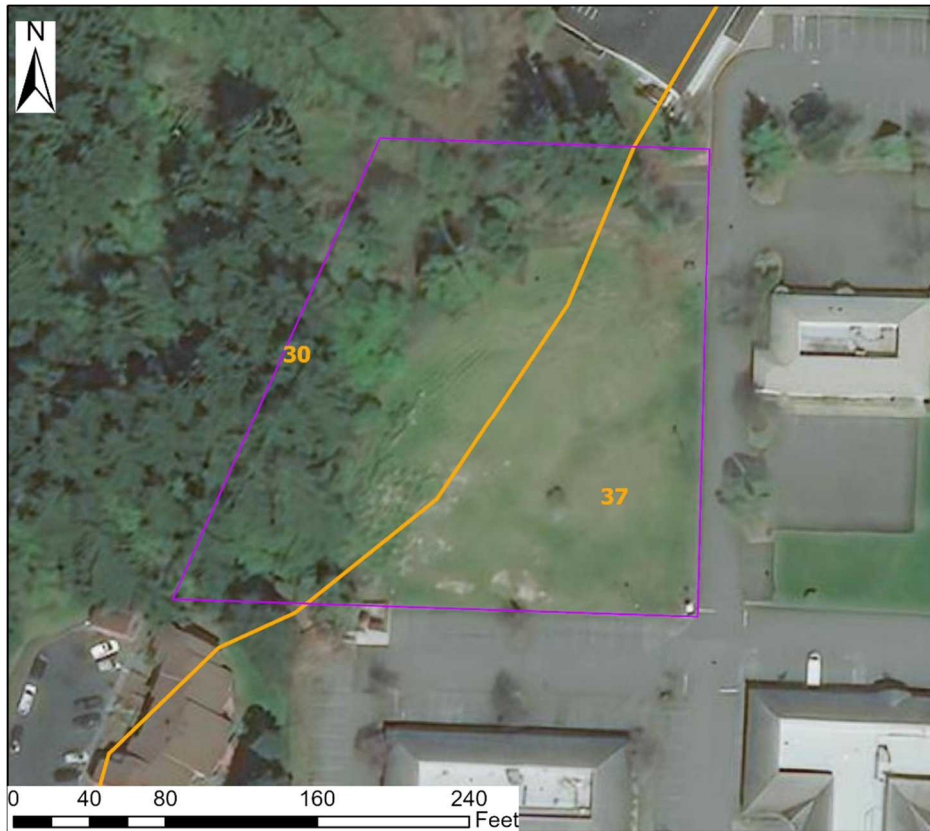
Soil Survey From USDA Natural Resources Conservation Service

According to the “Soil Survey of Kitsap County,” by the United States Department of Agriculture, Soil Conservation Service, the site soils are described as Kitsap silt loam, 30, with 15% to 30% slopes, and Norma fine sandy loam, 37.

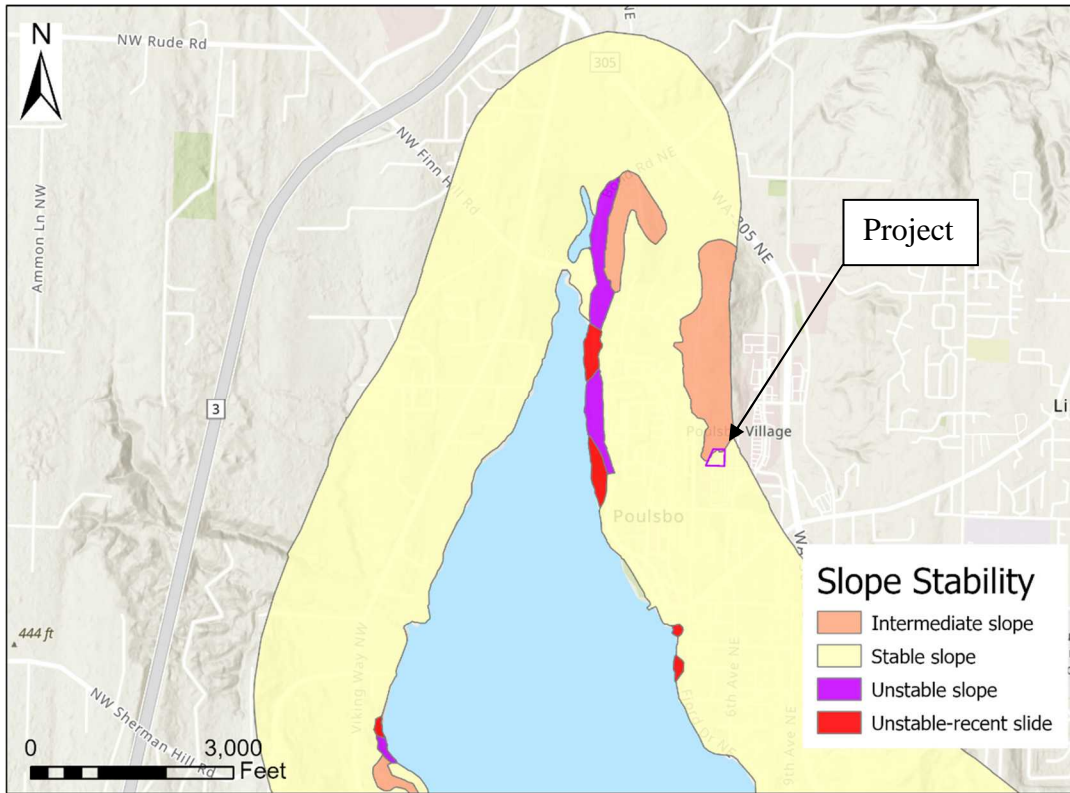
Map from Washington State Department of Ecology Website

According to the Coastal Zone Atlas of Kitsap County, Washington, the project is within and near terrain labeled 'Stable' and 'Intermediate' regarding potential landslide activity. Stable slopes are generally not prone to landslides due to small grades and accommodating geology. Historically, intermediate terrains have no known landslides. However, this site is considered inherently hazardous due the existing geology and/ or topography, and additional analyses and recommendations concerning the slopes are presented herein. A Stability Map from the Coastal Zone Atlas for the general area of this project is provided below:

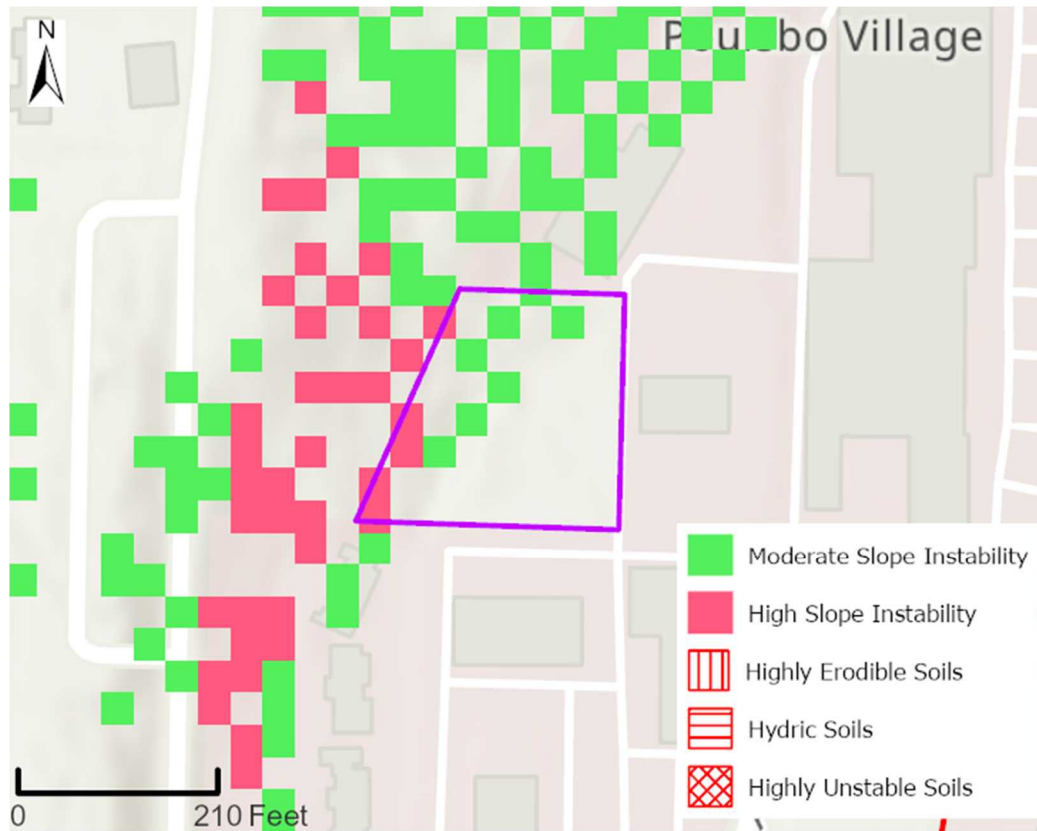
Map from Washington State Department of Natural Resources Website

According to the Department of Natural Resources (DNR) Interactive mapping, previous landslide activity is not recorded on or within the influence of the project. Per the Resource Map from DNR, the project is not within terrain labeled 'highly unstable' or 'highly erodible' relating to soils. DNR labeled portions of this project as medium slope instability with relation to slopes. This delineation is primarily dependent upon slopes and convergence. Secondly, lithology and precipitation are modeled within this delineation. In summary, this designation is based on mapping without field observations or knowledge of the specific site geology or soils. A resource map from DNR is provided below:

Based on the USCS description of the project soils, the surface soils are considered moderately erodible. According to the Resource Map from the Washington State DNR, as provided above, the project is not within terrain labeled ‘highly erodible.’
